Investigation of the UH-60 Main Rotor Spindle Assembly Retaining Rods P/N 70102-08102/-103

ARL-TR-1585

January 1998

The purpose of this investigation was to determine the root cause of the differences seen in the fatigue test data of UH-60 main rotor spindle assembly retaining rods from three different vendors.

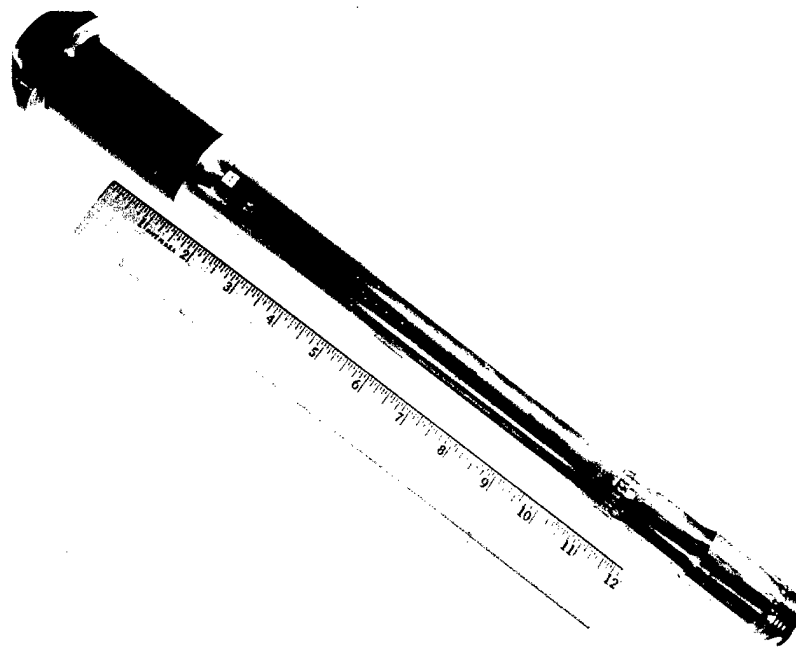
The as-received condition of the two halves of the failed retaining rods manufactured by SIK -00938 and -00973 are depicted in Figures 1–4, respectively. The as-received condition of the two halves of the failed retaining rods manufactured by PUR -174 and -177 are shown in Figures 5–8, respectively. Figures 9 and 10 depict the as-received failed retaining rods (opposite fracture halves were not received) manufactured by S&S -2 and -3, respectively. Each of the six failed spindle retaining rods was visually examined utilizing light optical microscopy. All six failures originated within the threaded section of the respective rods.

Figure 1. Failed SIK Rod -00938 in the As-Received Condition (Reduced 75%).

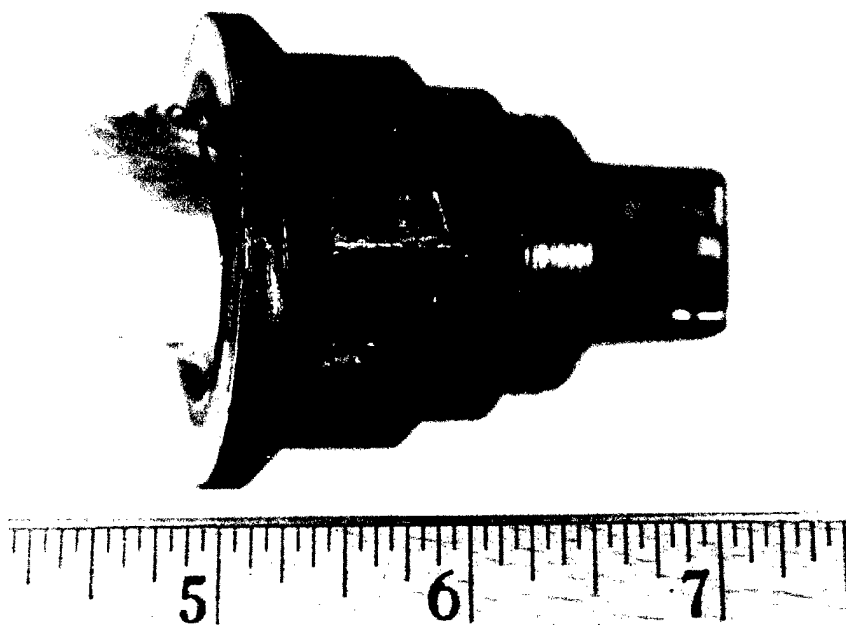
Figure 2. Failed Threaded End of SIK Rod -00938 in the As-Received Condition (Mag. 1.25x).

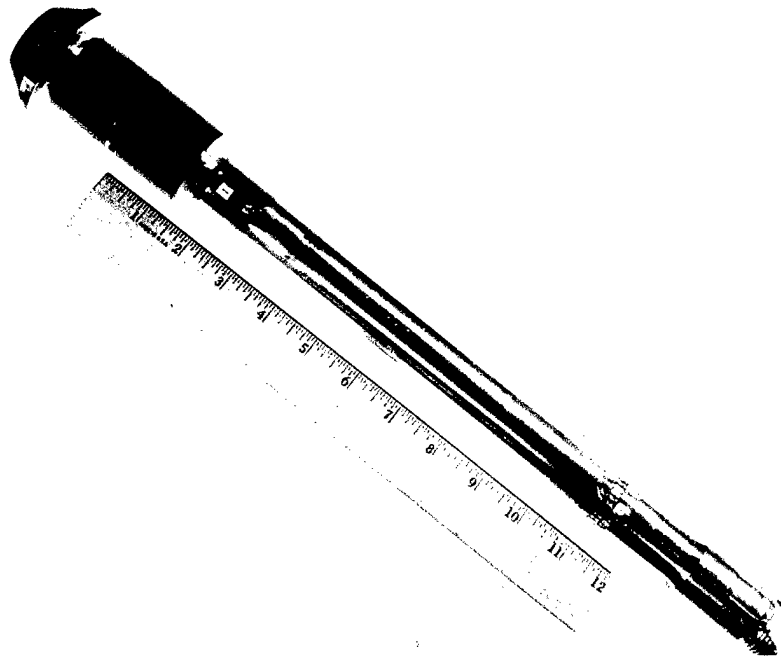
Figure 3. Failed SIK Rod -00973 in the As-Received Condition (Reduced 75%).

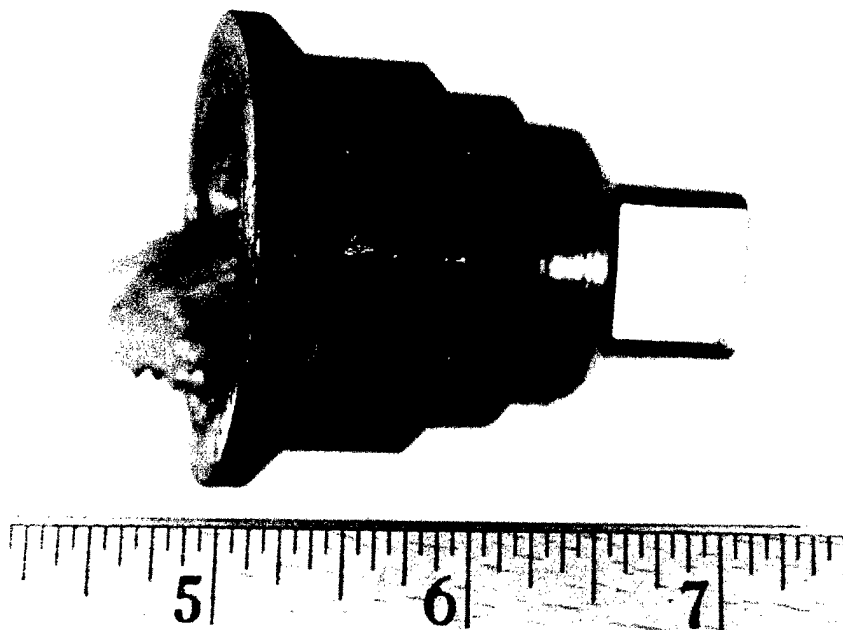
Figure 4. Failed Threaded End of SIK Rod -00973 in the As-Received Condition (Mag. 1.25x).

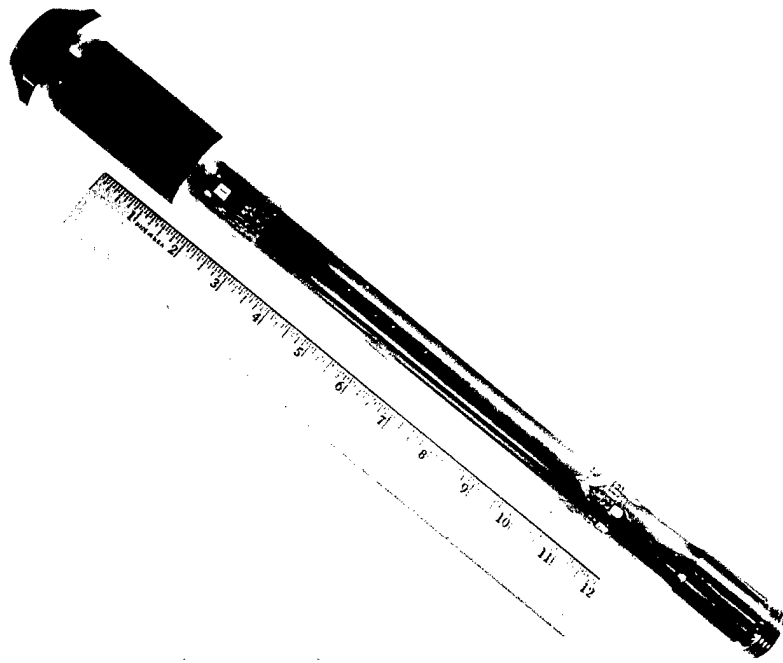
Figure 5. Failed PUR Rod -174 in the As-Received Condition (Reduced 75%).

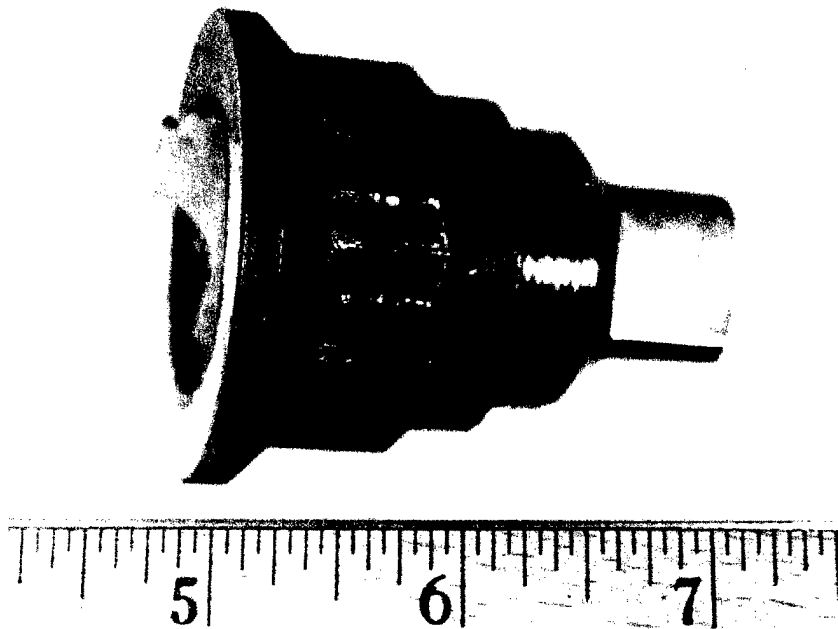
Figure 6. Failed Threaded End of PUR Rod -174 in the As-Received Condition (Mag. 1.25x).

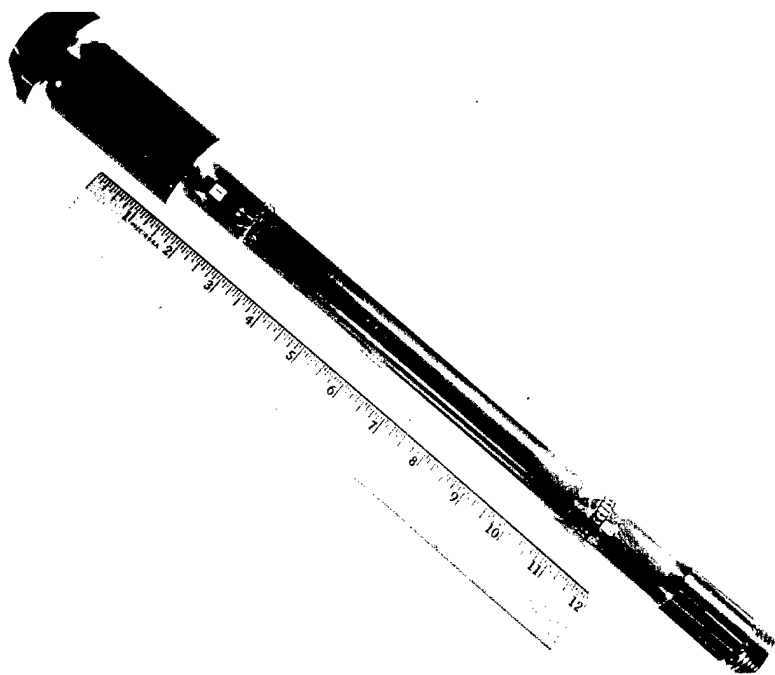
Figure 7. Failed PUR Rod -177 in the As-Received Condition (Reduced 75%).

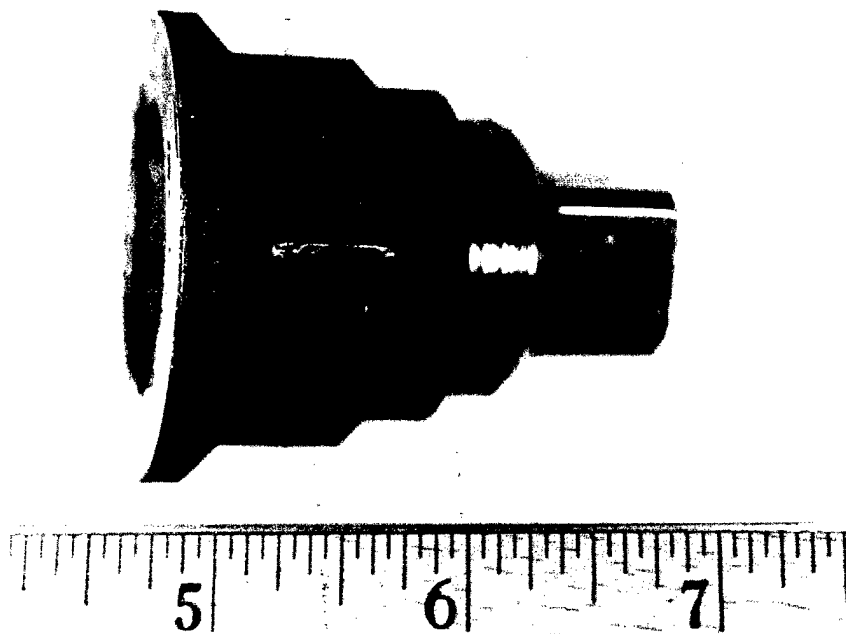
Figure 8. Failed Threaded End of PUR Rod -177 in the As-Received Condition (Mag. 1.25x).

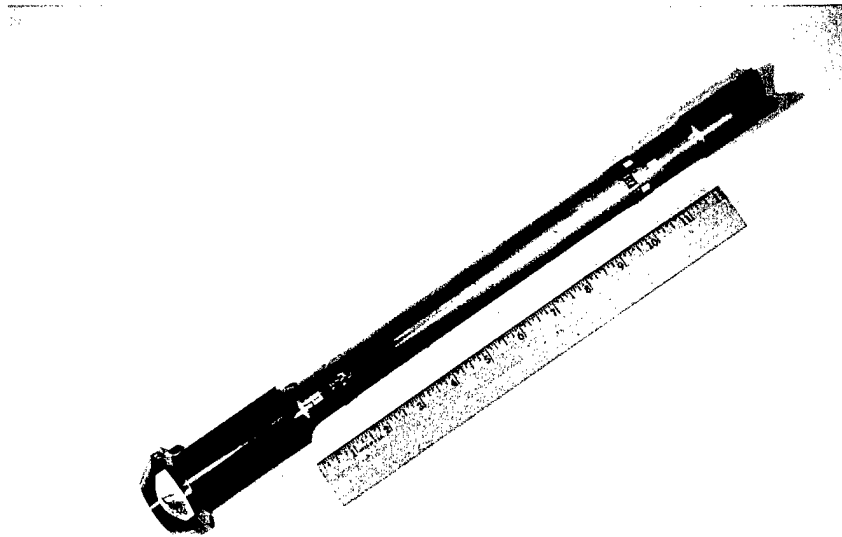
Figure 9. Failed S&S Rod -2 in the As-Received Condition (Reduced 80%).

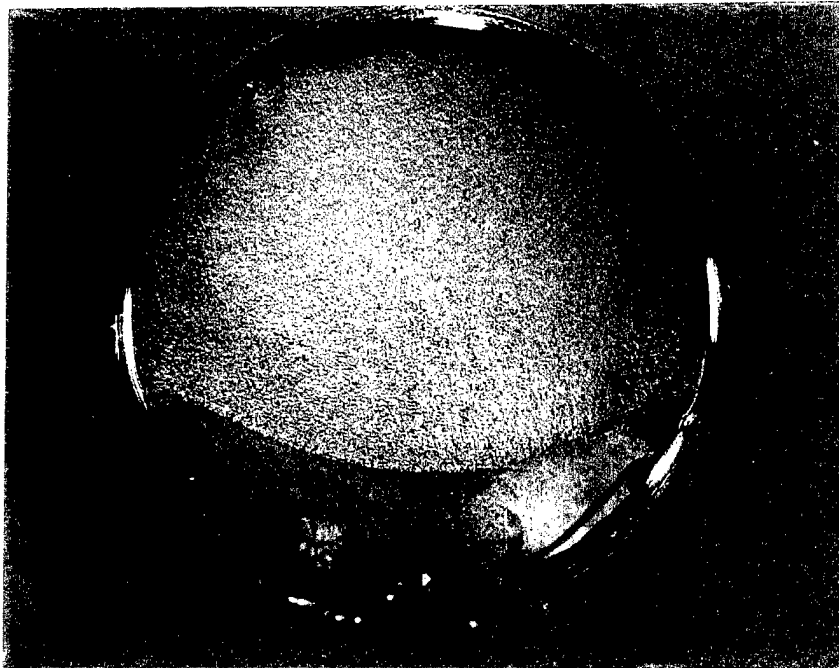
It was observed that the two failed specimens fabricated by PUR had relatively flat uniform fracture surfaces indicative of most fatigue failures. The two failed specimens had fracture surfaces that were remarkably similar. Multiple origin sites (greater than 20) were observed on both surfaces, all initiating along the root radius of the same thread. The surface profiles of the threads were examined and compared to those of SIK rods. The roots of the PUR threads were slightly rougher, containing more pronounced tool marks. No other abnormalities were observed along the threads. The fatigue zones covered approximately 80% of the fracture surface of the PUR rods, while the overload regions accounted for only 20% of the fracture surface. The fracture surfaces of the PUR failed specimens -174 and -177 are presented in Figures 14 and 15, respectively. The fatigue cracks propagated on a single plane, and no evidence of competing or secondary cracks was noted.

Figure 14. Fracture Surface of PUR Rod -174 in the As-Received Condition. Note the Increased Fatigue Zone as Opposed to the Fracture Surfaces of the SIK Rods (Mag. 2x).

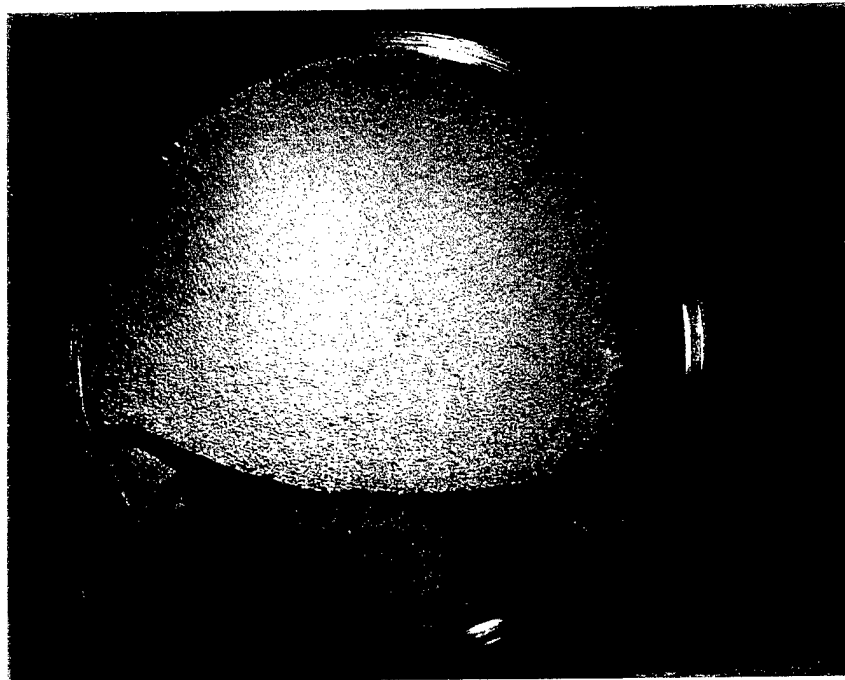
Figure 15. Fracture Surface of PUR Rod -177 in the As-Received Condition. Note the Increased Fatigue Zone as Opposed to the Fracture Surfaces of the SIK Rods (Mag. 2x).

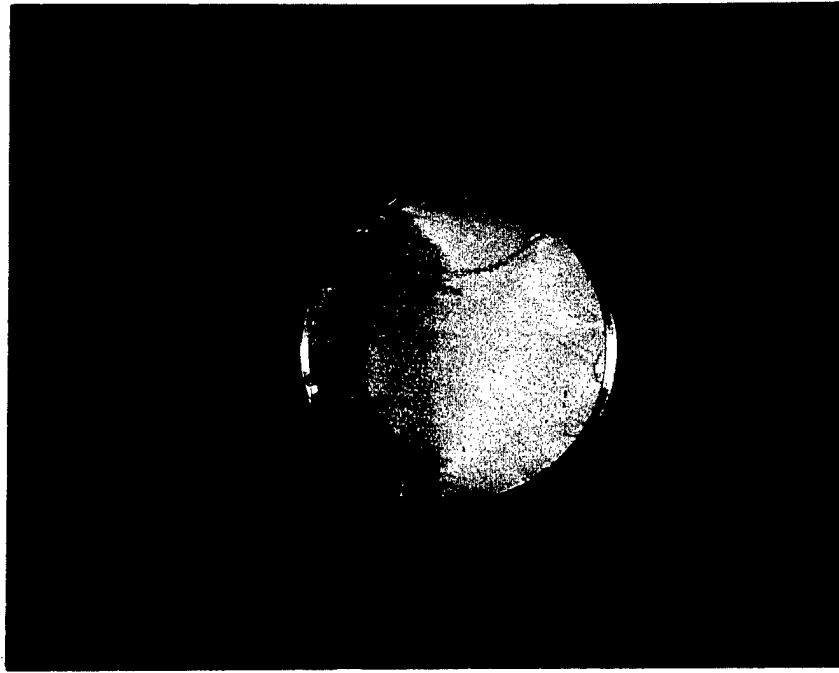
Figure 17. Fracture Surface of S&S Rod -3 in the As-Received Condition. Again, the Fatigue Region Is Within Focus. Note the Large Flat Fatigue Plane Similar to the PUR Samples (Mag. 1.2x).

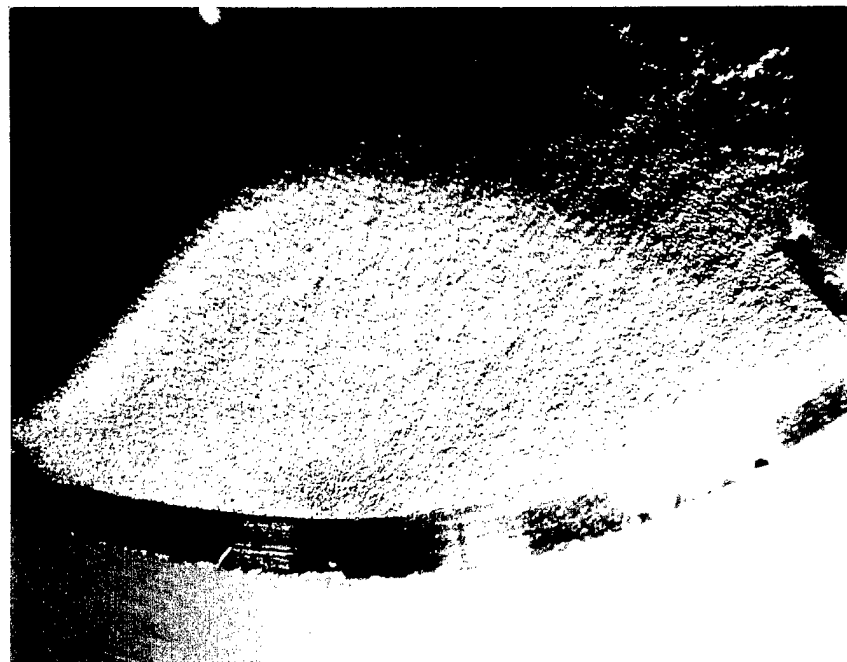
The fracture surface of S&S rod -2 resembled that of both SIK rods. Fracture propagated on two competing crack fronts, giving a total fatigue region of approximately 40% as depicted in Figure 16. This specimen had an initial shear angle of 75–80° that progressed onto another shear plane of approximately 40–45°. The fracture surface of S&S specimen -3, in comparison, appeared similar to the PUR rods as shown in Figure 17. The fatigue region appeared fairly flat and uniform, although two competing crack fronts were observed, totaling 70% of the fracture surface. A classic thumbnail feature that comprised the secondary fracture, is depicted in Figure 18. Like both PUR specimens, specimen -3 had a 40–45° shear angle.

Figure 18. A Thumbnail Crack Noted on the Fracture Surface of S&S Rod -3 (Mag. 10x).

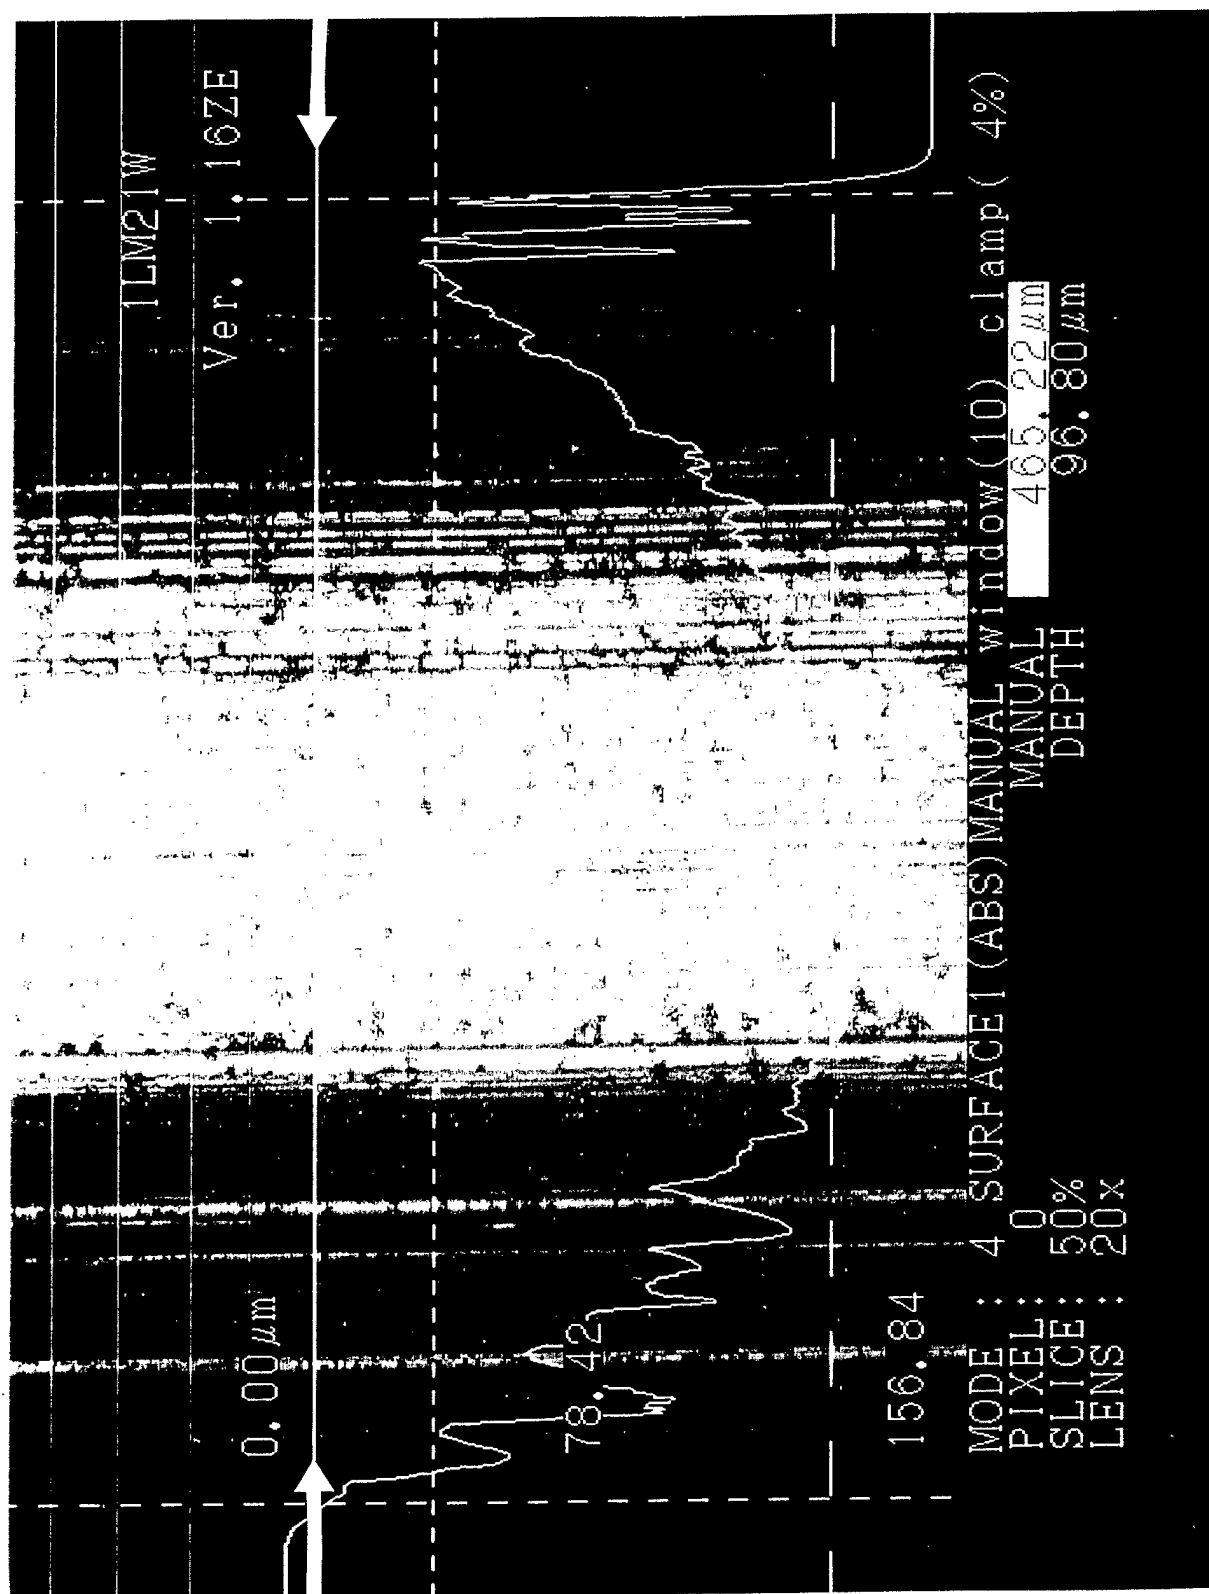
Figure 19. Lasertec Linear Scan Profile of SIK -00938 Rod Typical Thread Root (Mag. 500x).

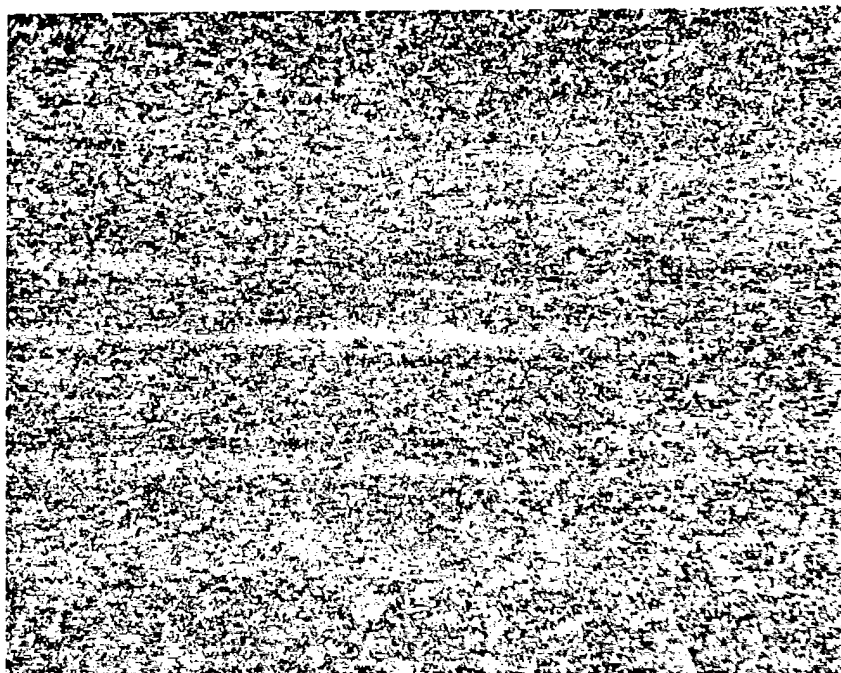
Figure 37. Structure of SIK -00973 in the Longitudinal Direction Showing Minimal Delta Ferrite Within the Banding. This Was the Only Delta Ferrite Noted Within the Structure of the SIK Samples. Vilella's Reagent (Mag. 100×).

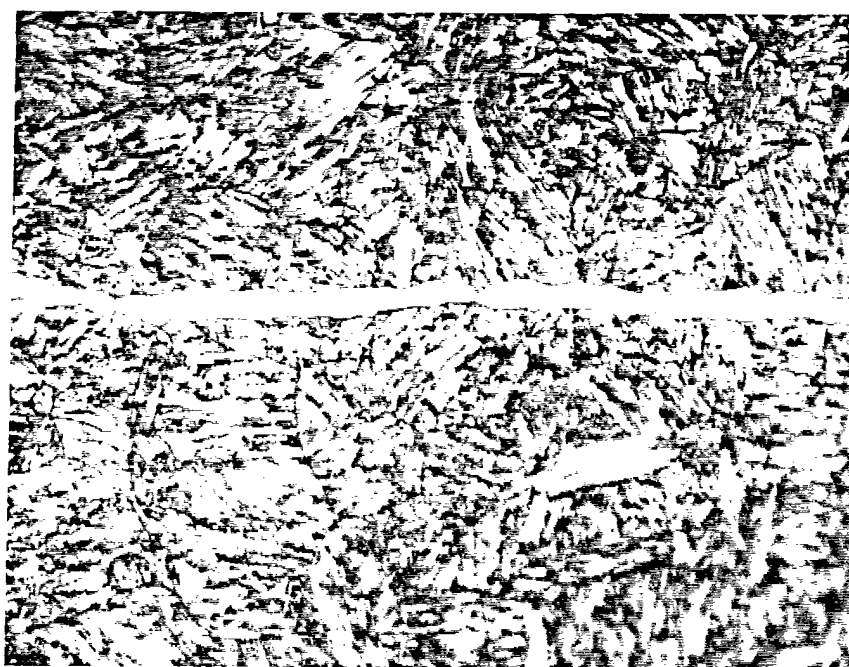
Figure 40. Enlarged View of the Ferrite Stringer Noted Within SIK Sample -00973. Vilella's Reagent (Mag. 1kx).

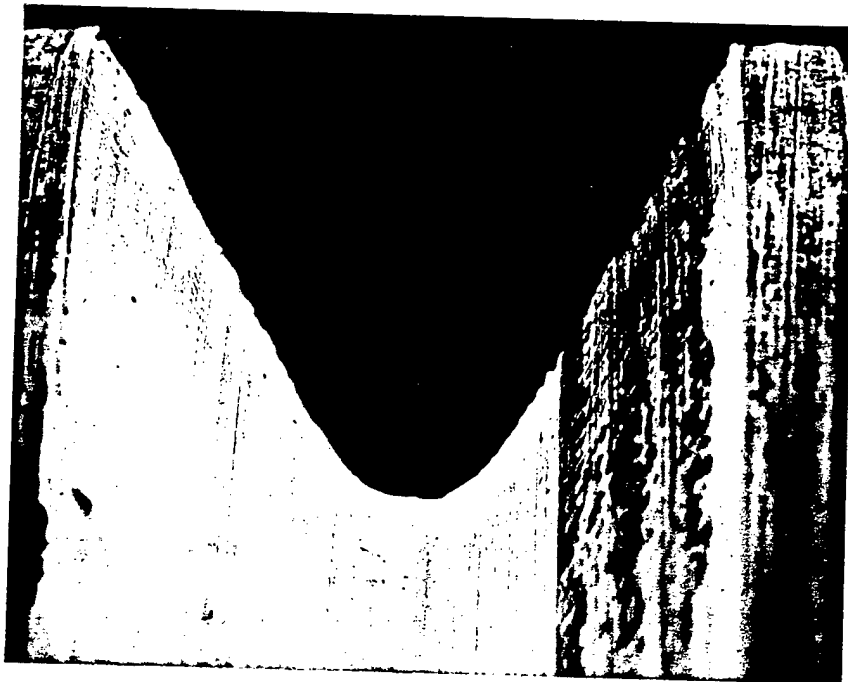
Figure 55. SEM Micrograph Depicting the Rough PUR Thread Root (Mag. 50x).

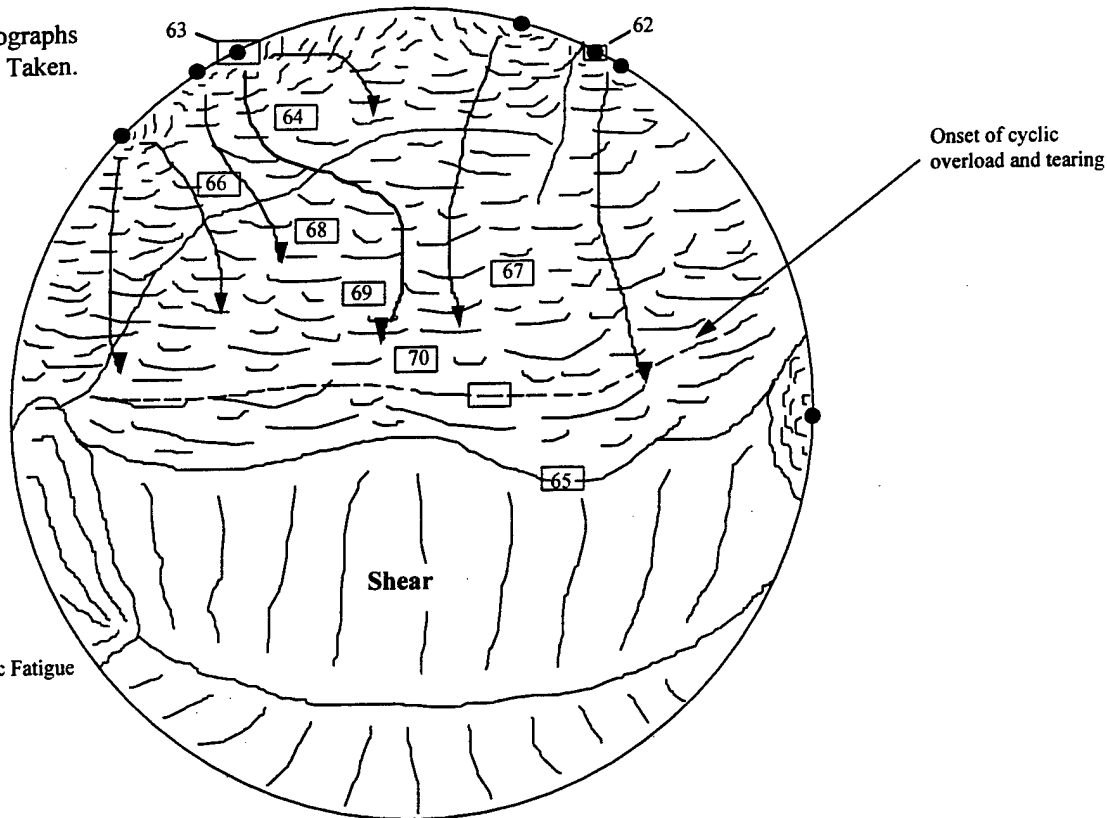
Figure 56. Schematic of the Fracture Surface of SIK Tie Rod -00938.

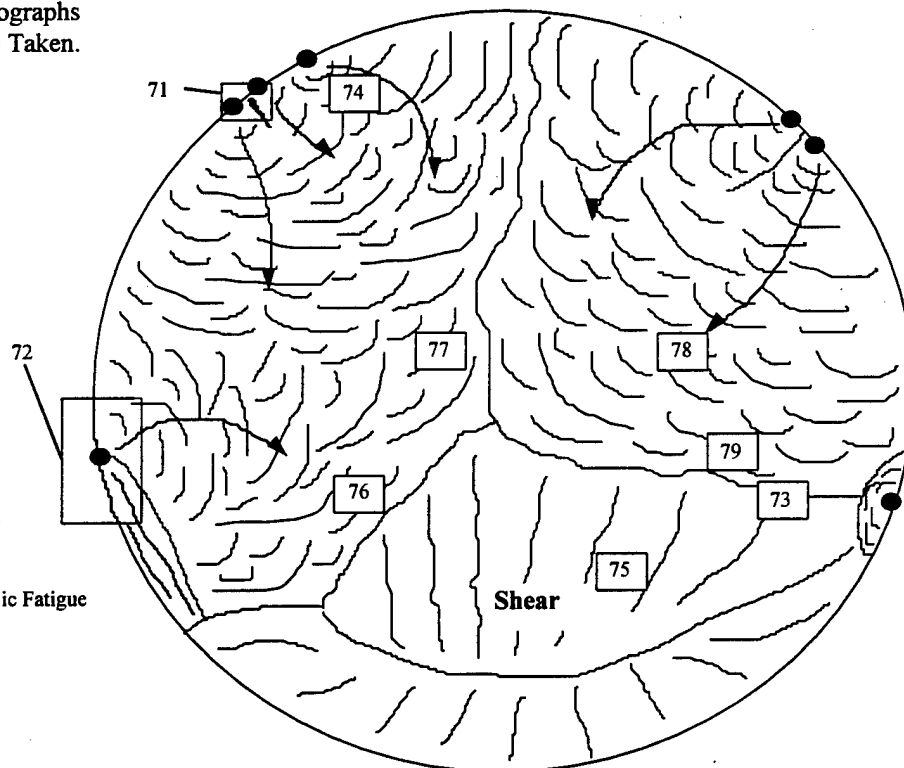
Figure 57. Schematic of the Fracture Surface of SIK Tie Rod -00973.

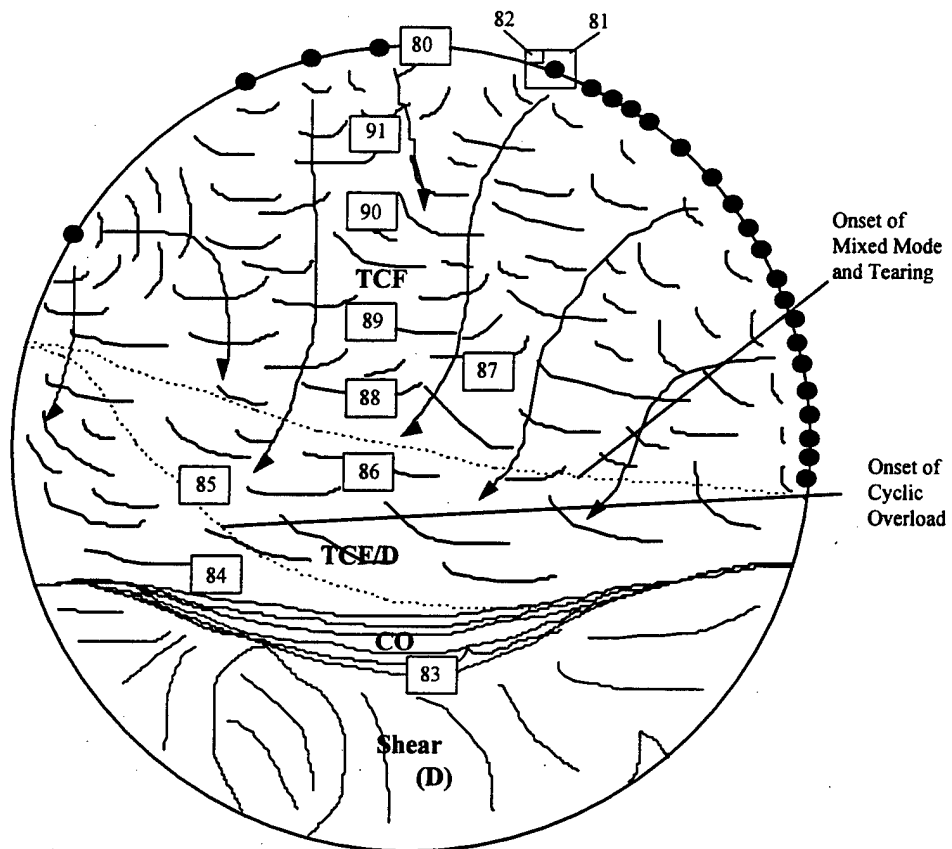
Figure 58. Schematic of the Fracture Surface of PUR Tie Rod -174.

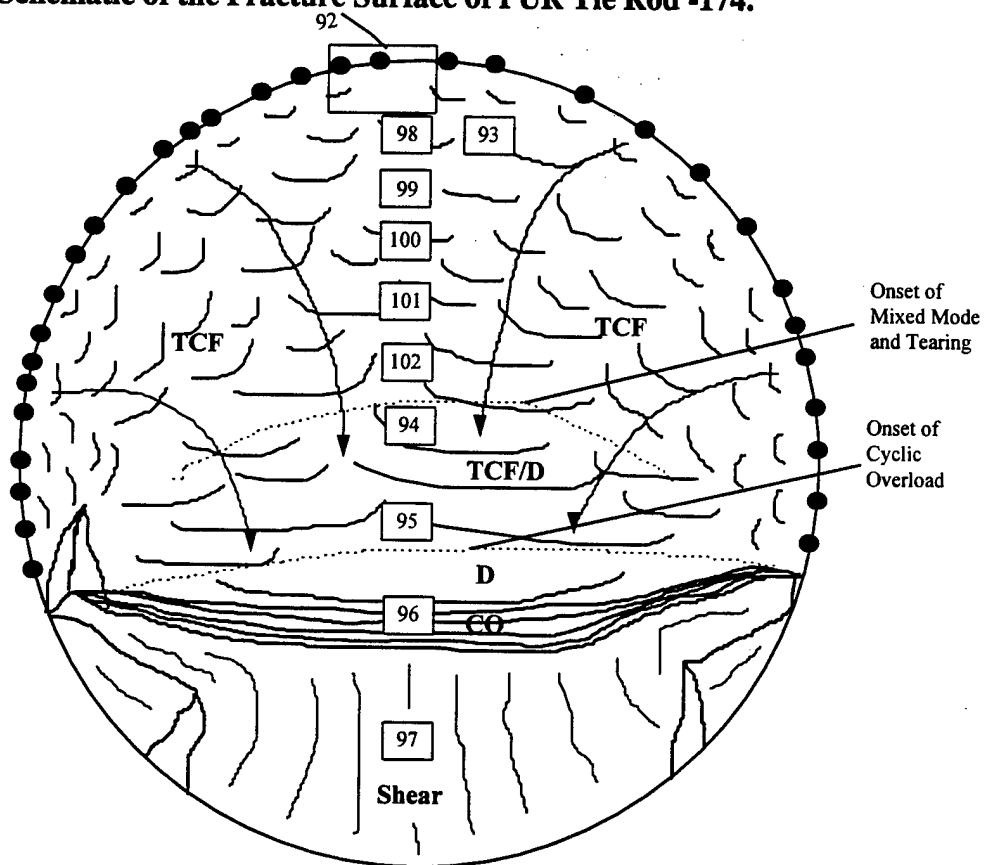
Figure 59. Schematic of the Fracture Surface of PUR Tie Rod -177.

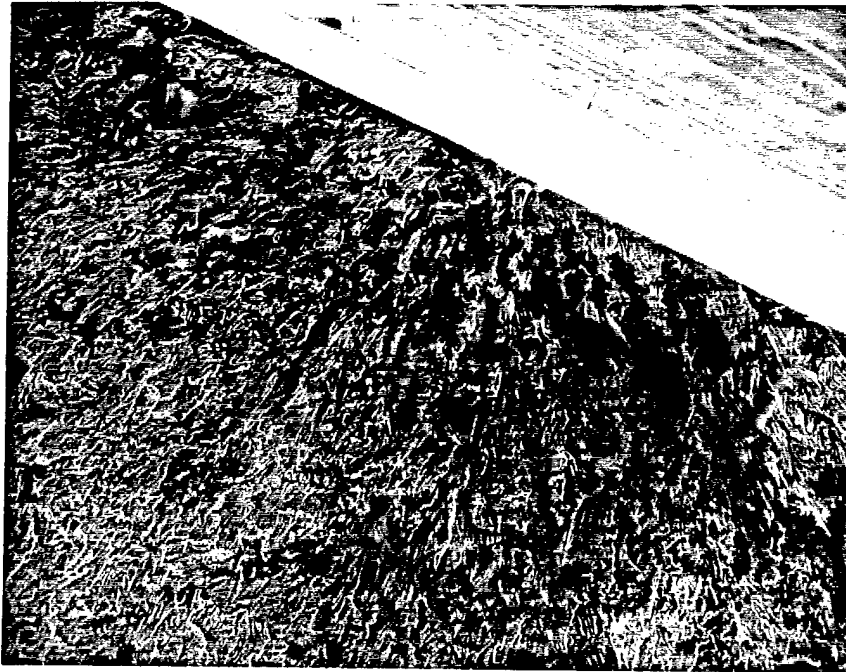
Figure 62. A Typical Origin on the Fracture Surface of SIK Rod -00938 (Mag. 500x).

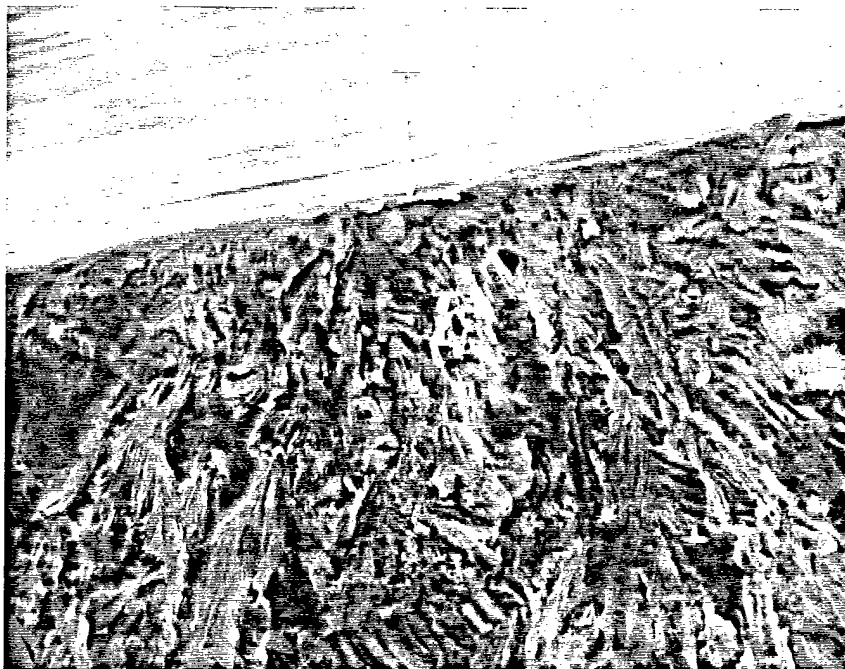
Figure 63. Another Origin on the Fracture Surface of SIK Rod -00938 (Mag. 1kx).

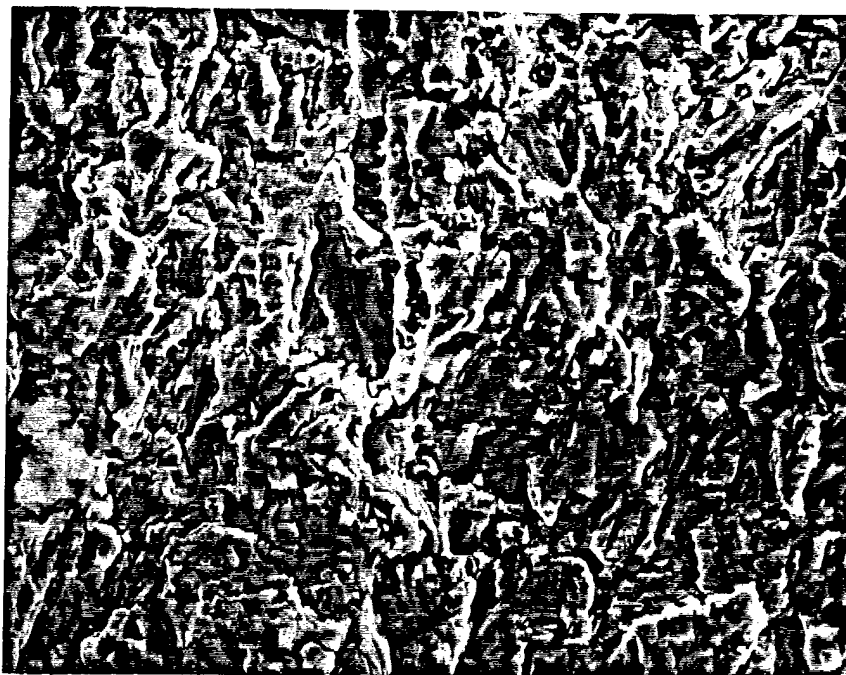
Figure 64. Typical Transgranular Morphology of SIK Rod -00938. This Morphology Was Characteristic of the Fatigue Region (Mag. 1kx).

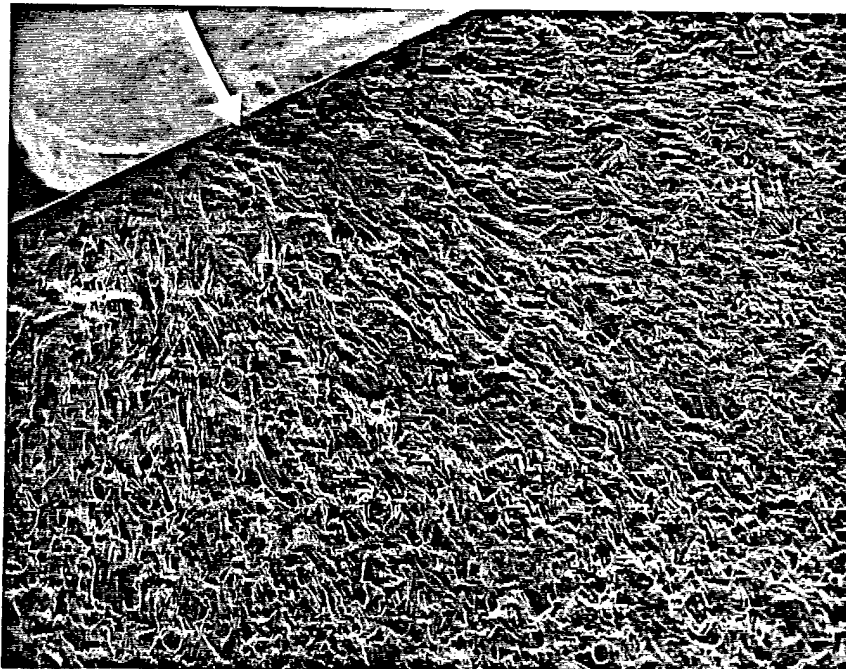
Figure 71. Typical Origin Noted on the Fracture Surface of SIK Rod -00973 (Mag. 200x).

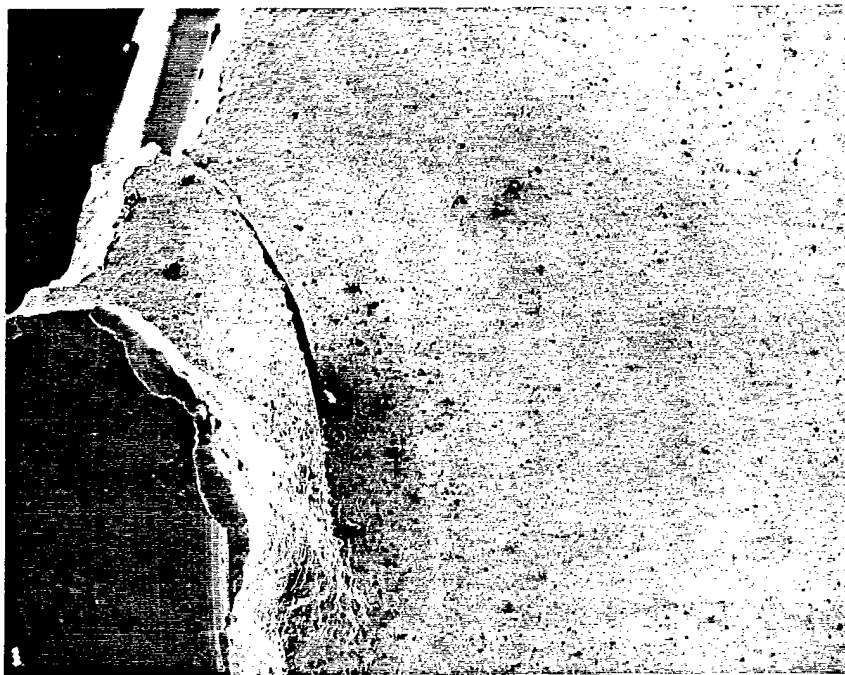
Figure 72. Typical Origin Noted on the Fracture Surface of SIK Rod -00973 (Mag. 20x).

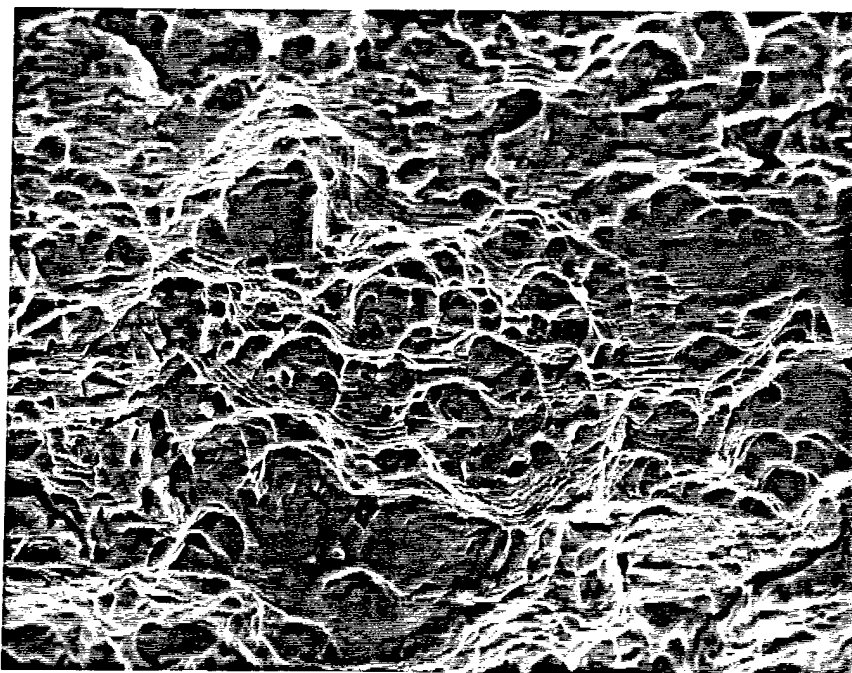
Figure 73. The Transgranular/Ductile Morphology of SIK Rod -00973 Away From the Origins (Mag. 1kx).

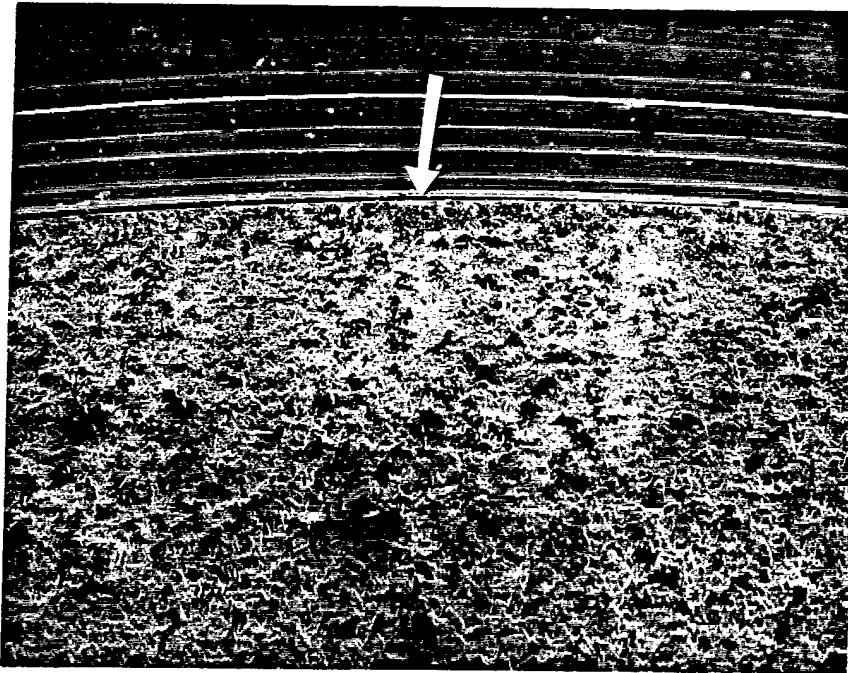
Figure 80. Typical Origin Located on the Fracture Surface of PUR Rod -174 (Mag. 50x).

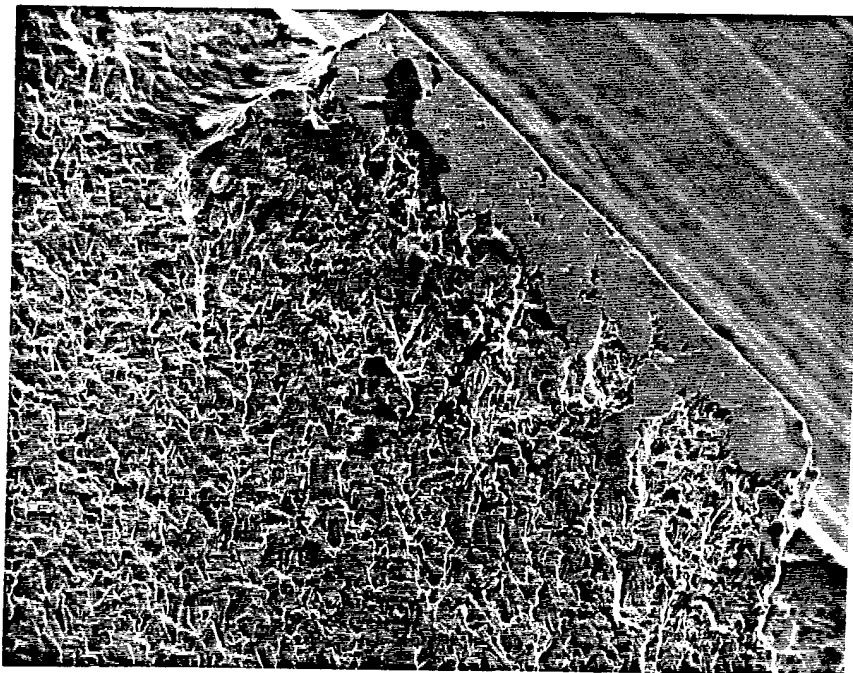
Figure 81. Typical Origin Located on the Fracture Surface of PUR Rod -174 (Mag. 150x).

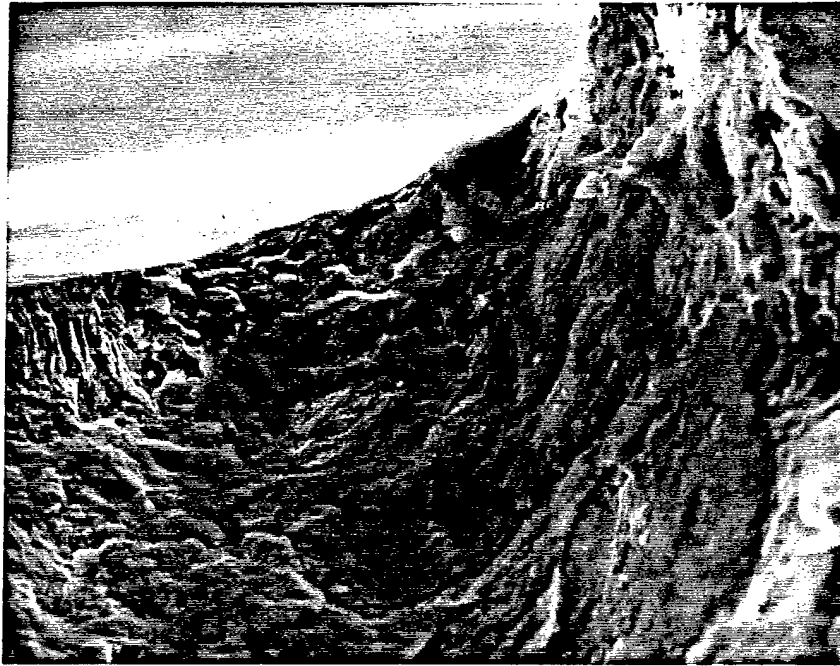
Figure 82. Detail of Origin Located on the Fracture Surface of PUR Rod -174 (Mag. 750x).

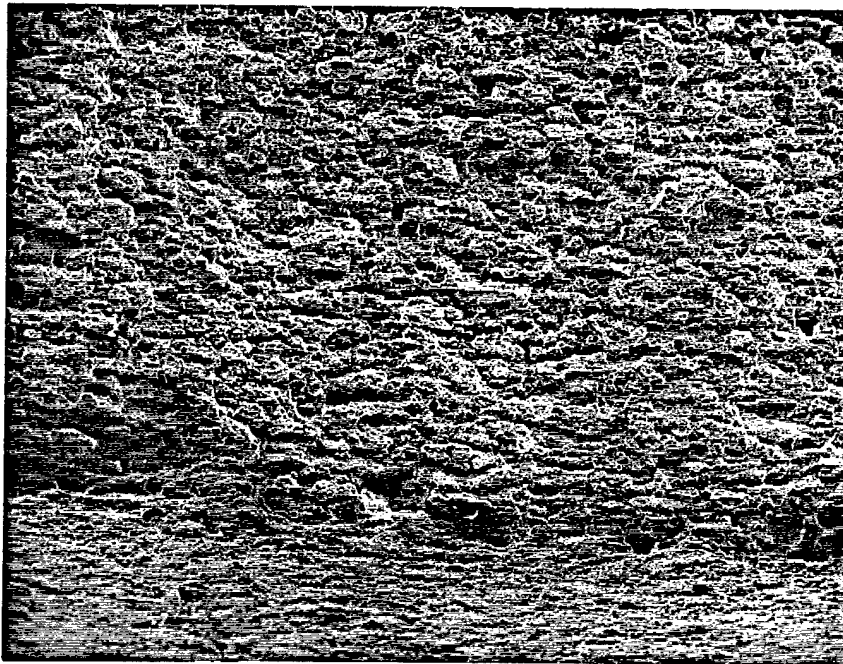
Figure 83. The Morphology of PUR Rod -174 Consisting of a Transition Zone Between Cyclic Overload and Shear (Mag. 50x).

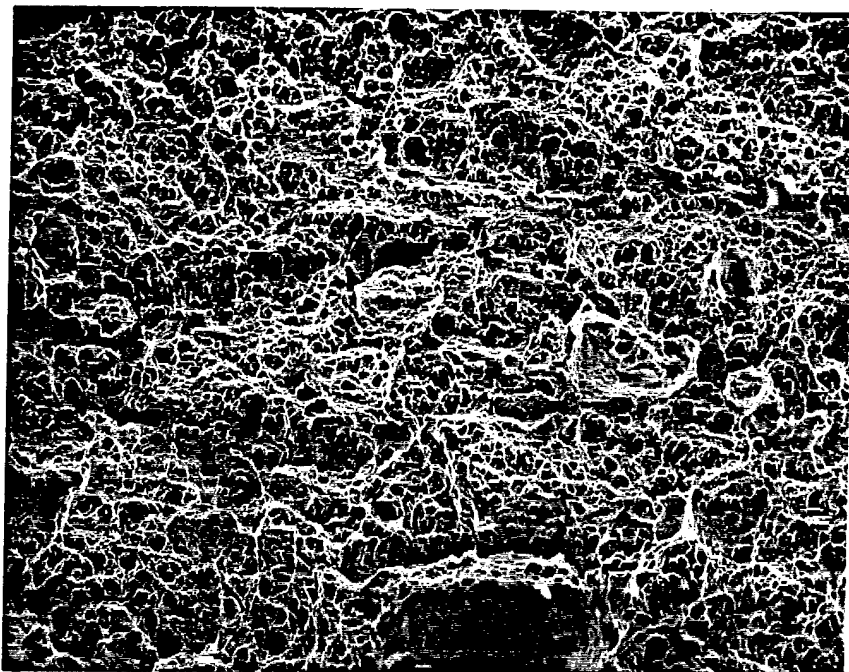
Figure 84. Cyclic Overload Morphology on the Fracture Surface of PUR Rod -174 (Mag. 200x).

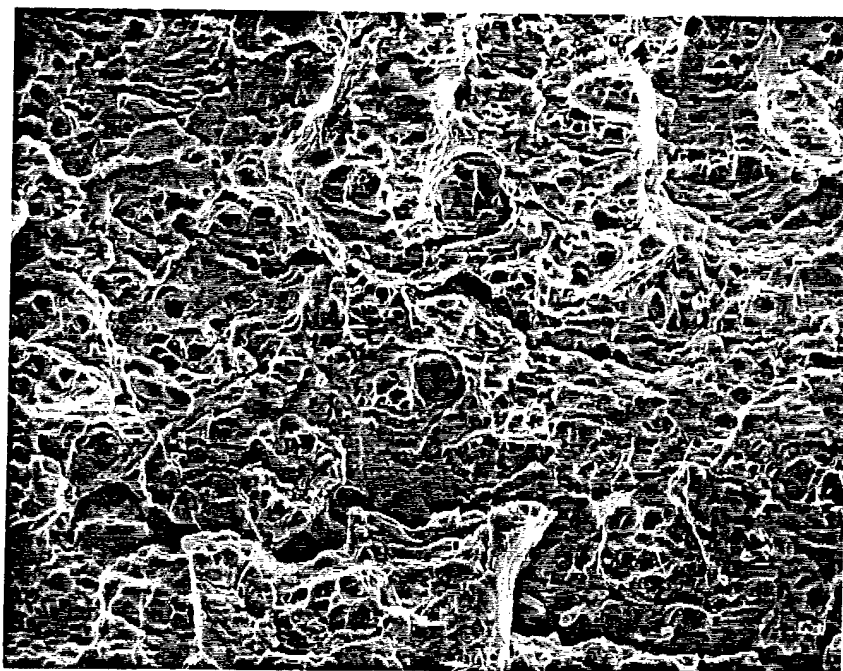
Figure 85. A Morphology Consisting of Tearing as Well as Cyclic Overload Noted on the Fracture Surface of PUR Rod -174 (Mag. 500x).

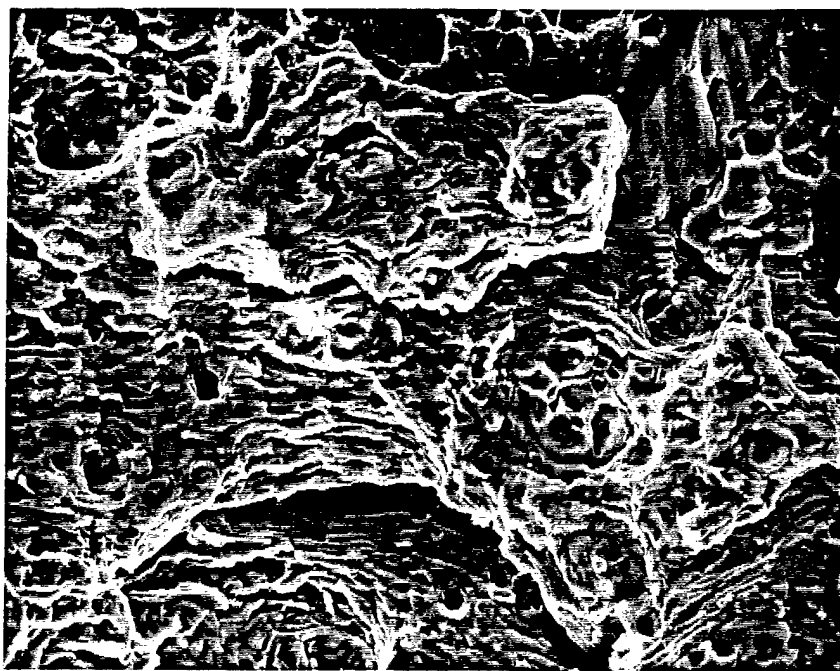
Figure 86. A Morphology Consisting of Striations, Tearing, and Ductility Observed on the Fracture Surface of PUR Rod -174 (Mag. 1kx).
